ABRADABLE DUAL-DENSITY CERAMIC TURBINE SEAL SYSTEM

FINAL REPORT

**DETROIT DIESEL ALLISON DIVISION
GENERAL MOTORS CORPORATION
INDIANAPOLIS, INDIANA 46206**

**NASA LEWIS RESEARCH CENTER
CONTRACT NAS 3-22012**

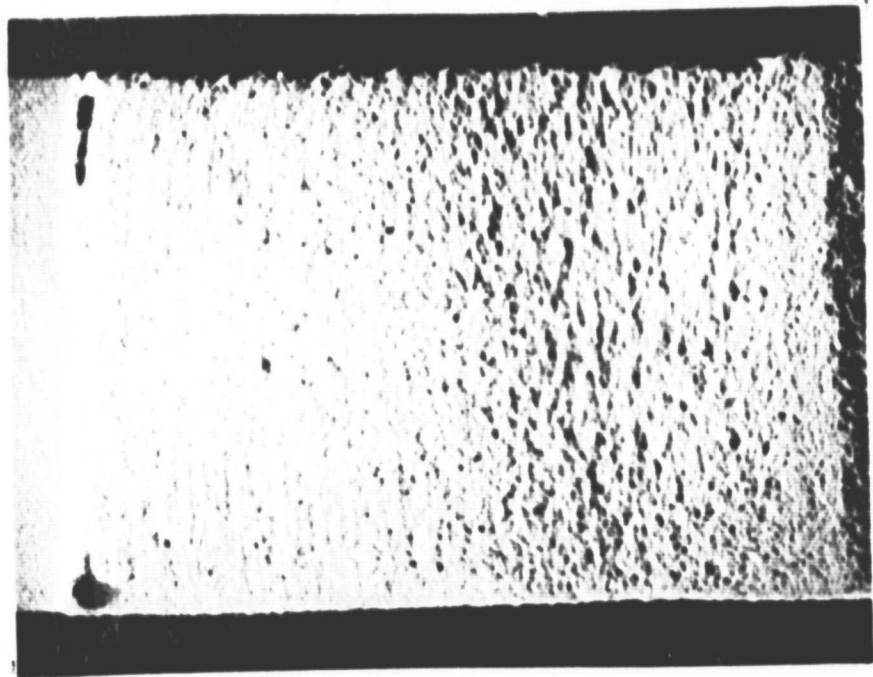
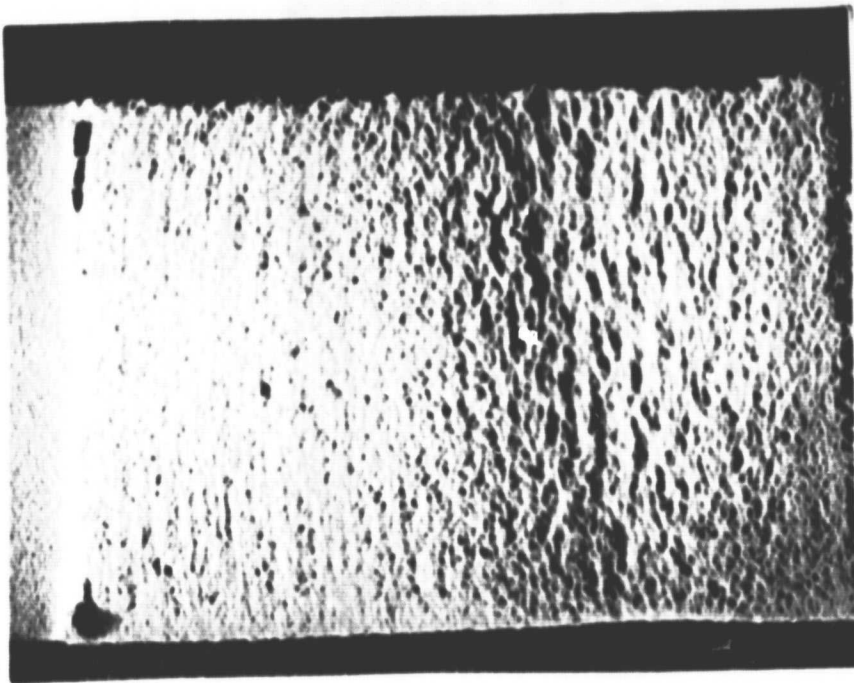
c. Erosion signature (60 min. exposure)

d. Erosion signature (120 min. exposure)

Figure 36 Cont'd. Erosion results (continued) for System III-J
(Table III) Magn: 3X

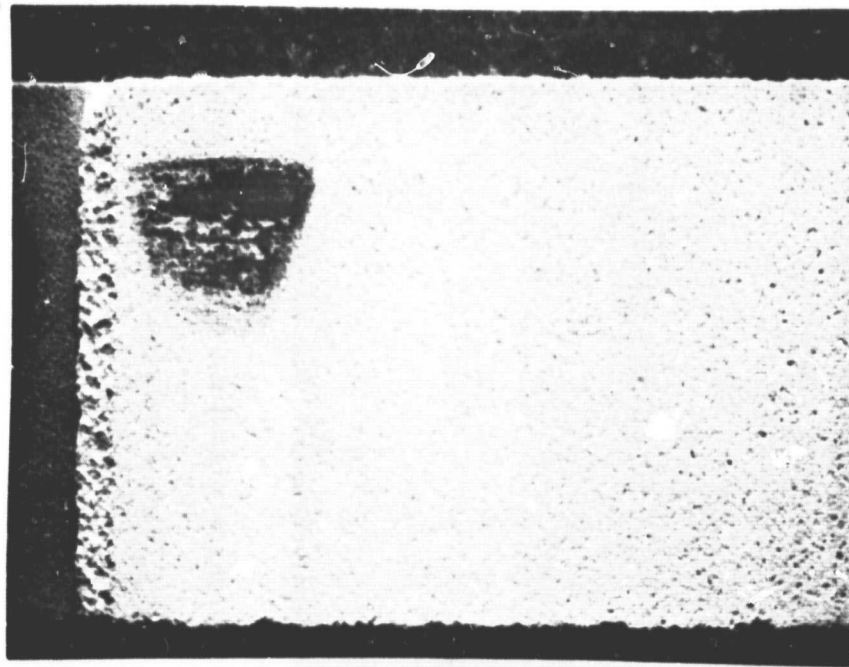
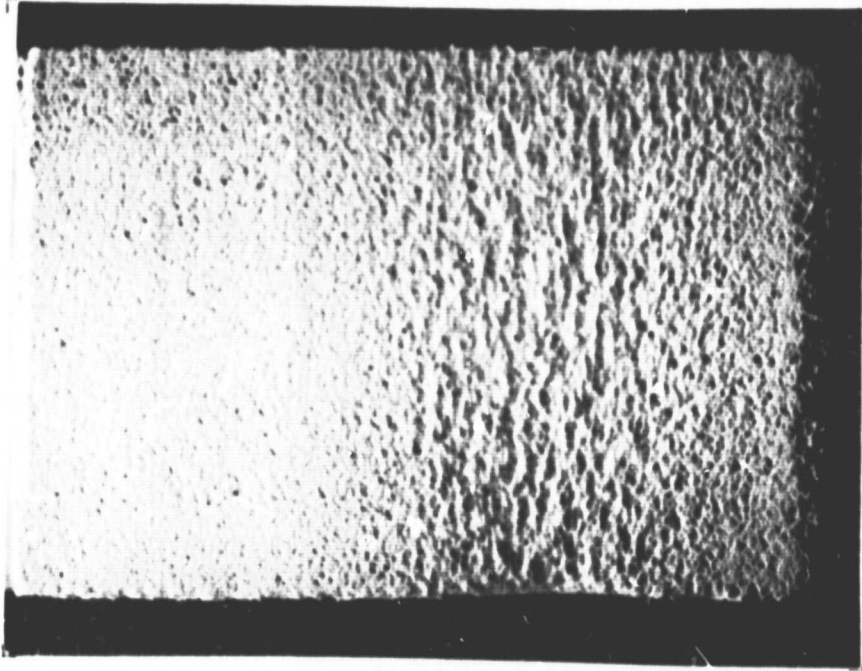
a. Abradability wear scar
(Rub direction

b. Erosion signature (30 min. exposure)
(Flow direction

Figure 37 Abradability and initial erosion results for System III-K
(Table III) Magn: 3X

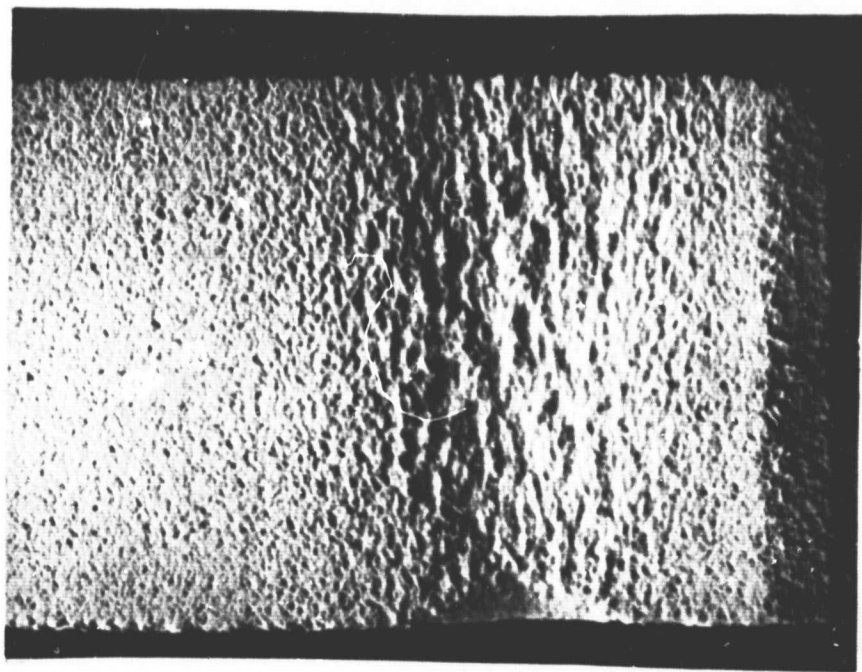
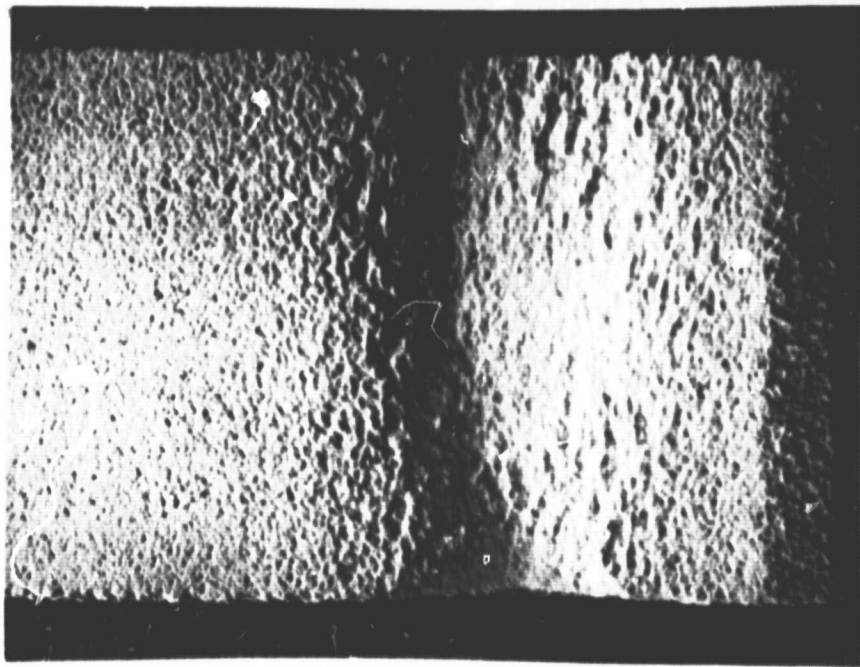
c. Erosion signature (60 min. exposure)

d. Erosion signature (120 min. exposure)

Figure 37 Cont'd. Erosion results (continued) for System III-K
(Table II) Magn: 3X

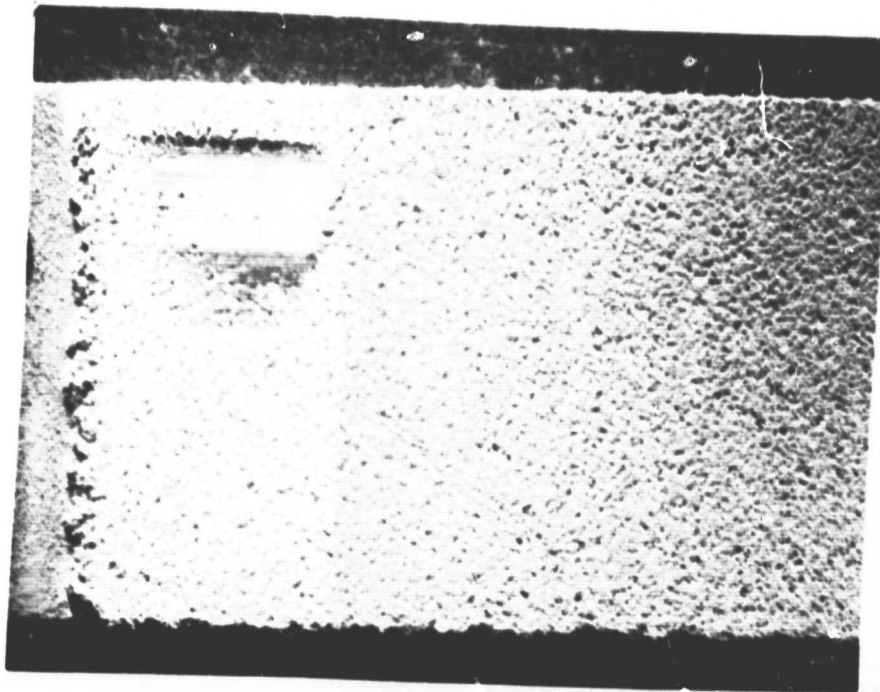
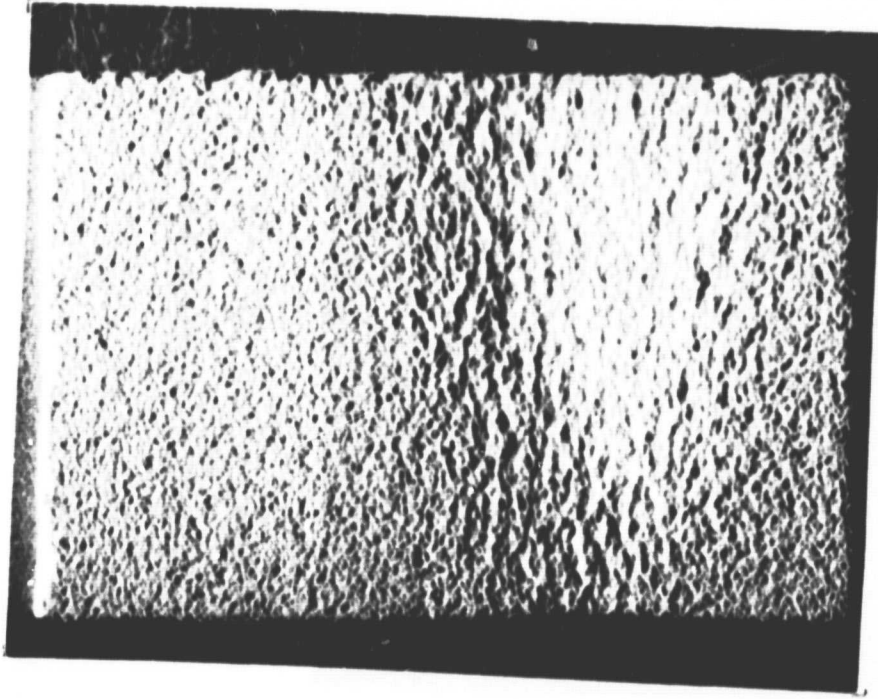
a. Abrasability wear scar
(Rub direction →)

b. Erosion signature (30 min. exposure)
(Flow direction →)

Figure 38 Abrasability and initial erosion results for System III-L
(Table III) Magn: 3X

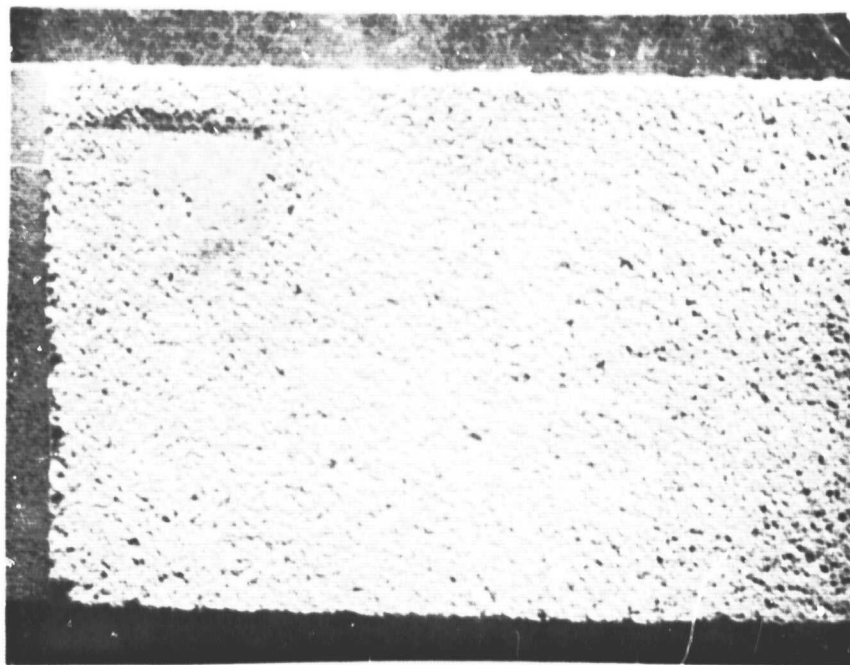
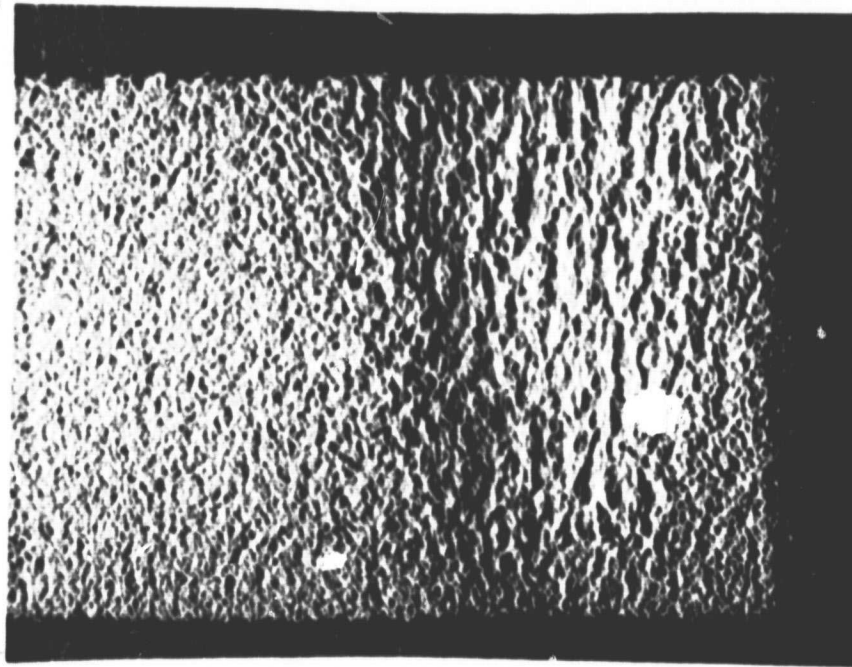
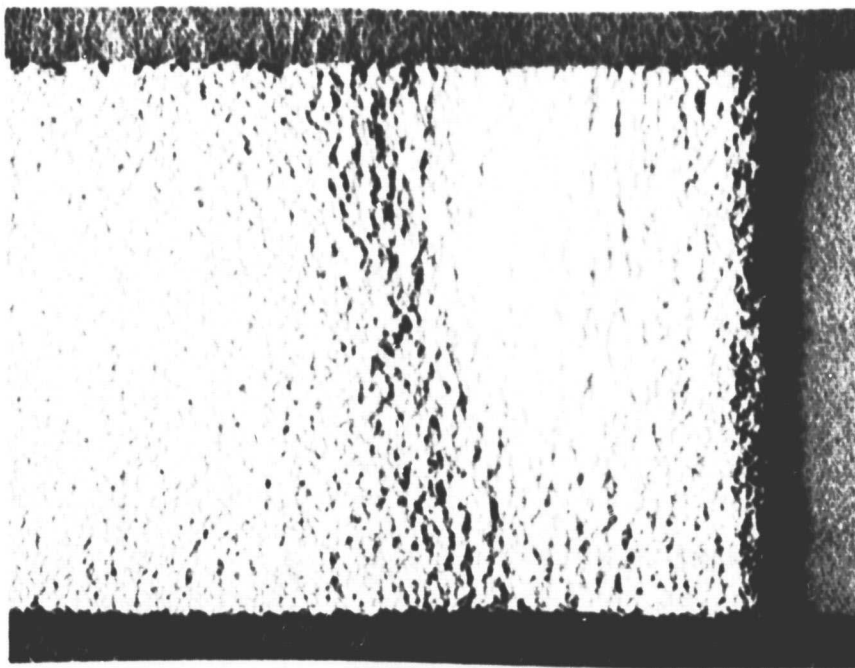
a. Abrasability wear scar
(Rub direction →)

b. Erosion signature (30 min. exposure)
(Flow direction →)

Figure 39 Abrasability and initial erosion results for System III-M
(Table III) Magn: 3X

c. Erosion signature (60 min. exposure)
(Flow direction →)

Coating destroyed
during test

Figure 39 Cont'd. Erosion results (continued) for System III-M
(Table III) Magn: 3X

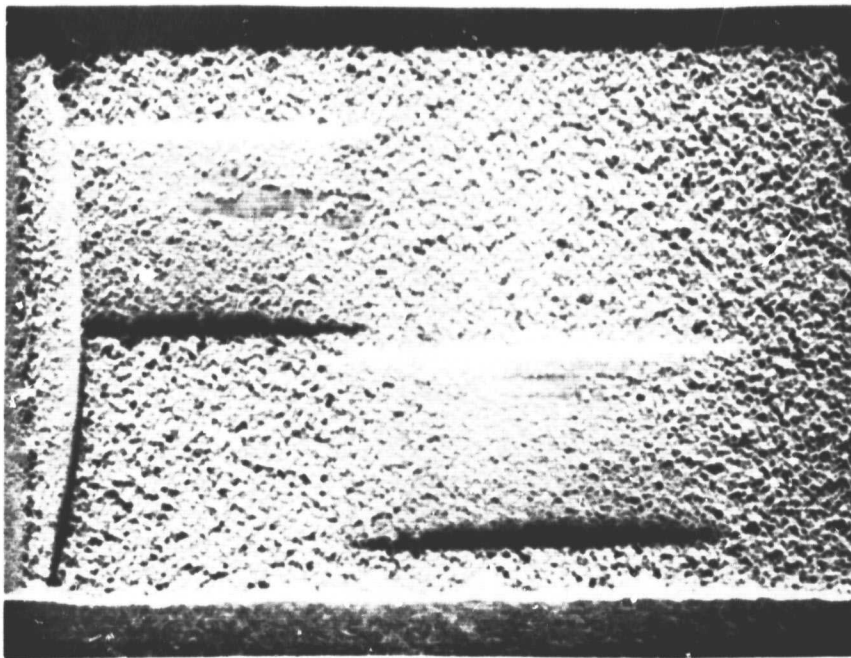
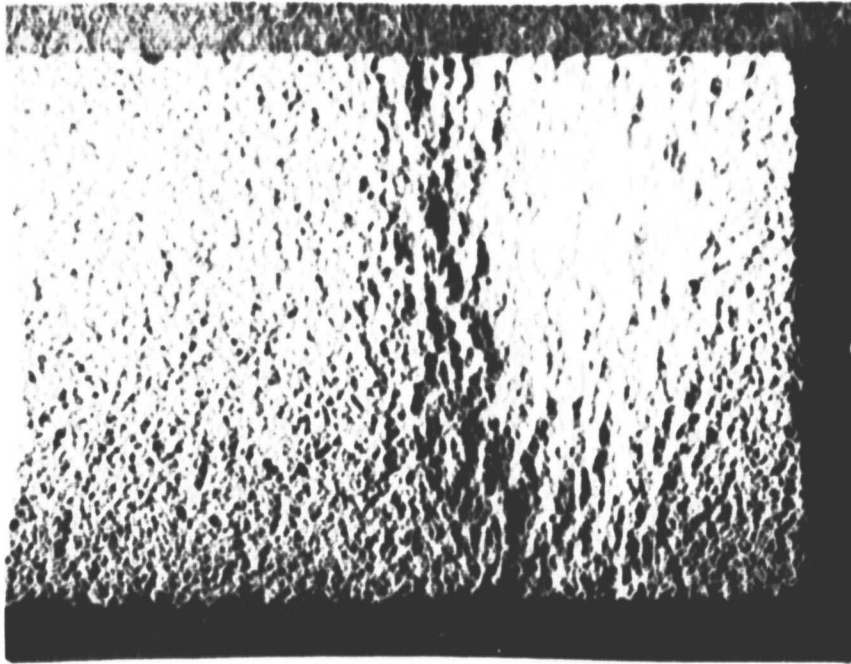
a. Abradability wear scar

b. Erosion signature (30 min. exposure)

Figure 40 Abradability and initial erosion results for System III-N
(Table III) Magn: 3X

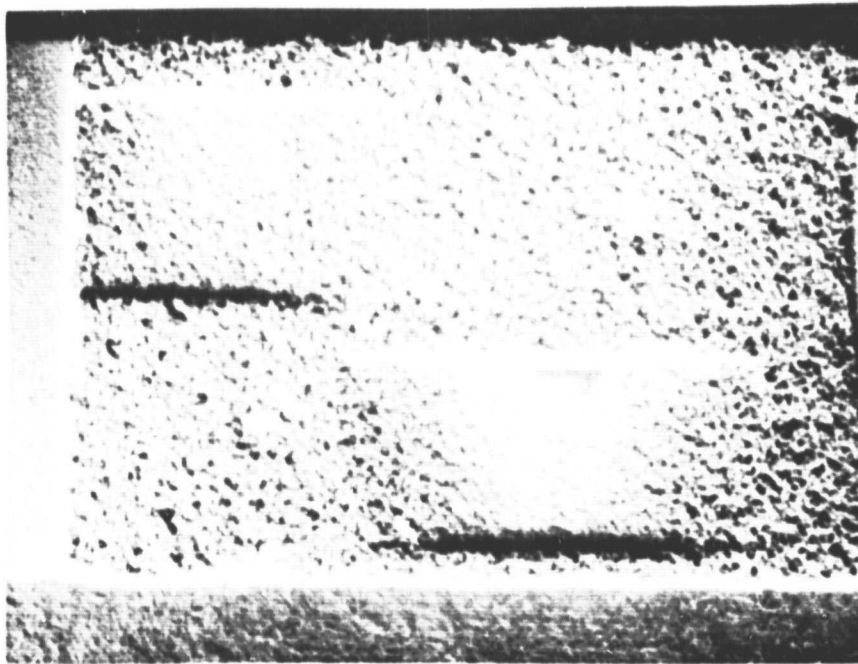
a. Abrasability wear scar
(Rub direction →)

b. Erosion signature (30 min. exposure)
(Flow direction →)

Figure 41 Abrasability and initial erosion results for System III-p
(Table III) Magn: 3X

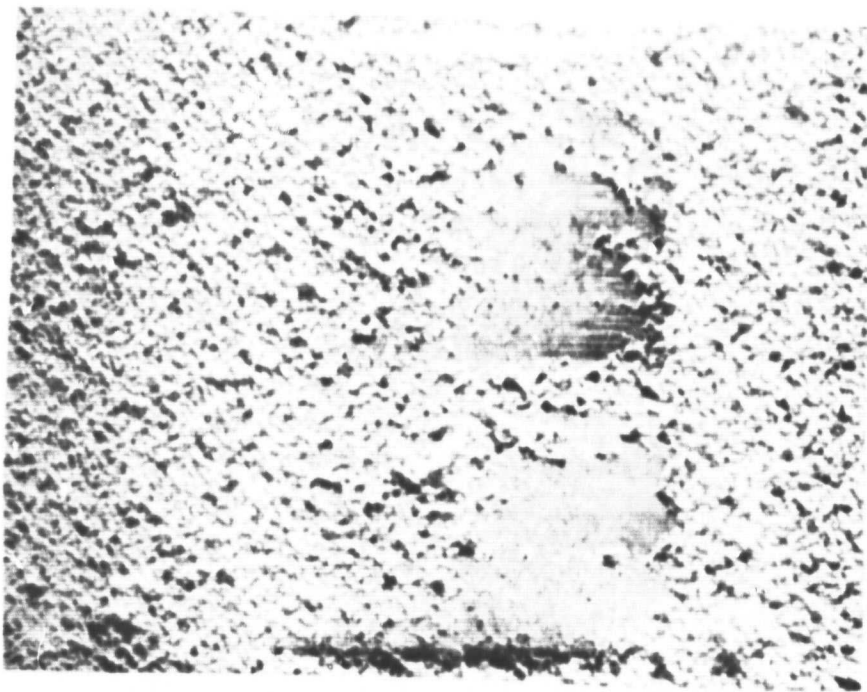
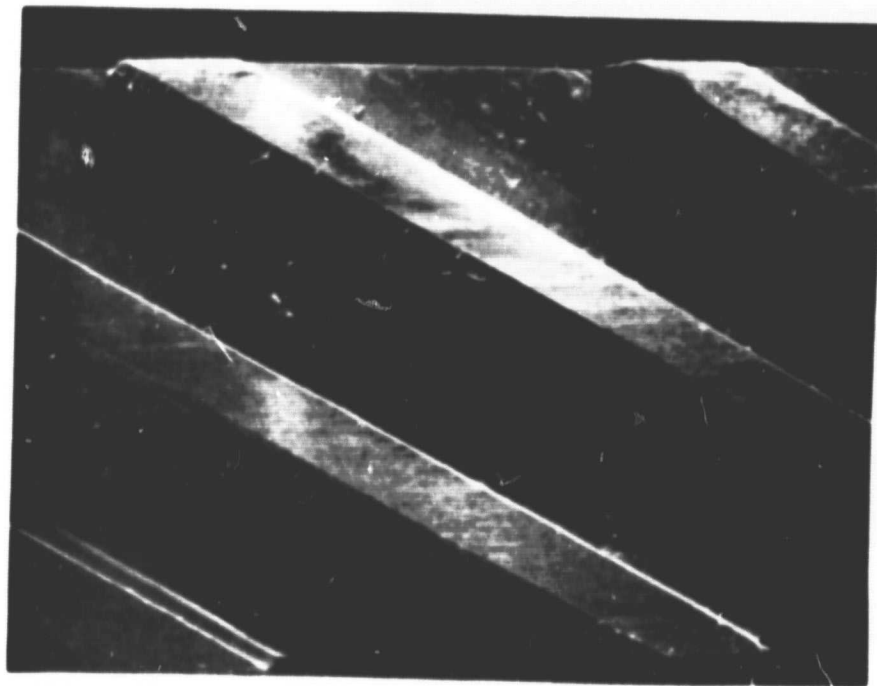
Because only the 20/80 and 18/82 ratio systems, prepared by using the mid range parameters (SD 1, PL 1), indicated a reasonable balance between abrasability and erosion resistance, high speed rig testing was restricted to these systems. Results of the abrasability tests, showing the rub wear scar and blade tip condition for the 20 v/o matrix/80 v/o filler system (System III-N) are presented in Figure 42.

a Blade Track Wear Scar

b Blade Tip Condition

Incursion Rate .0025 cm/sec (.001 in/sec)
Blade Tip Speed 229 m/sec (750 ft/sec)
Depth of Rub .018 cm (.007 in)

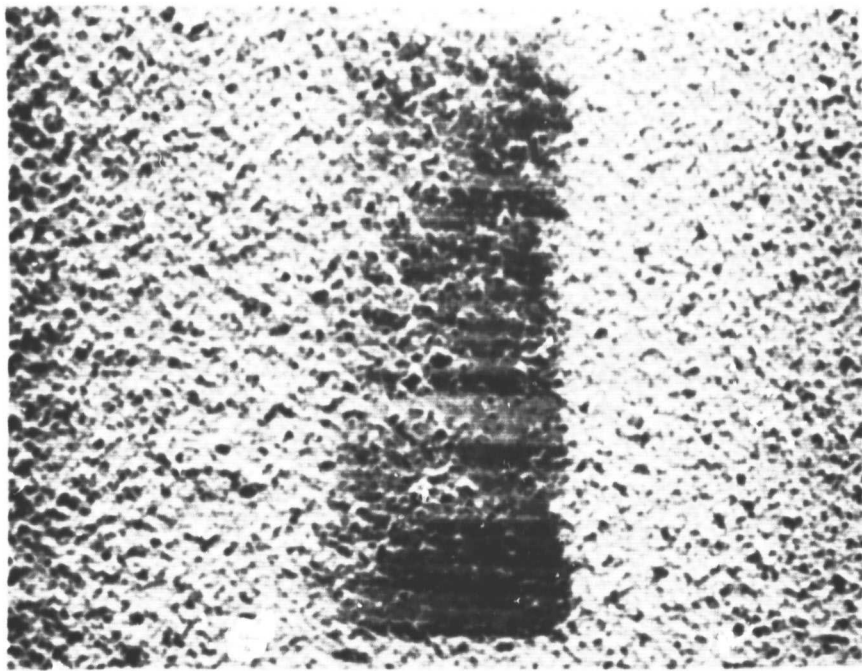
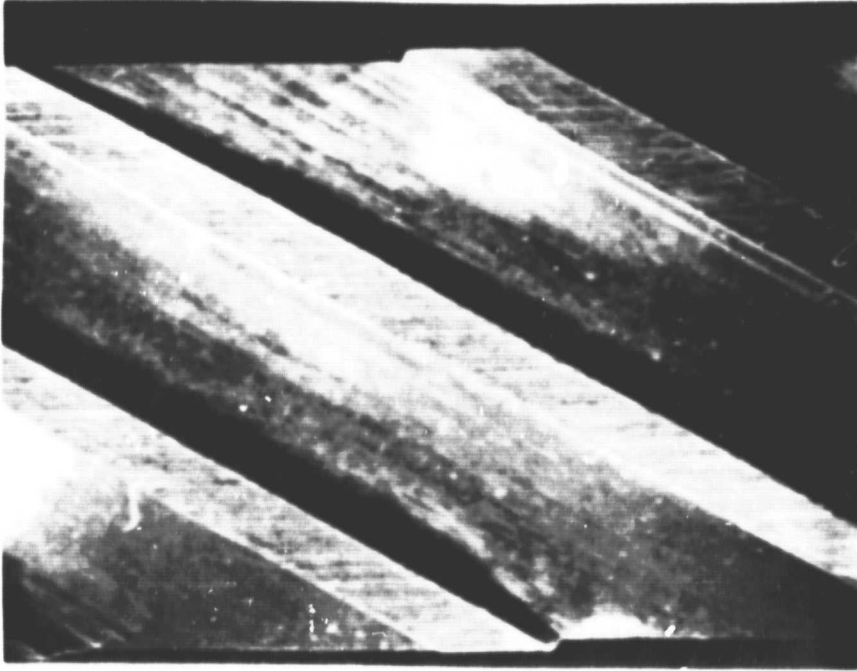
Results obtained for the system comprised of 18 v/o matrix/82 v/o filler (System III-O) are shown in Figure 43 where the rub wear scar and erosion signature following 30 minutes exposure are presented.

a Blade Track Wear Scar

b Blade Tip Condition

.0025 cm/sec (.001 in/sec)
229 m/sec (750 ft/sec)
.01 cm (.004 in)

Figure 43 Slow incursion rate high speed abrasability test results for System III 0

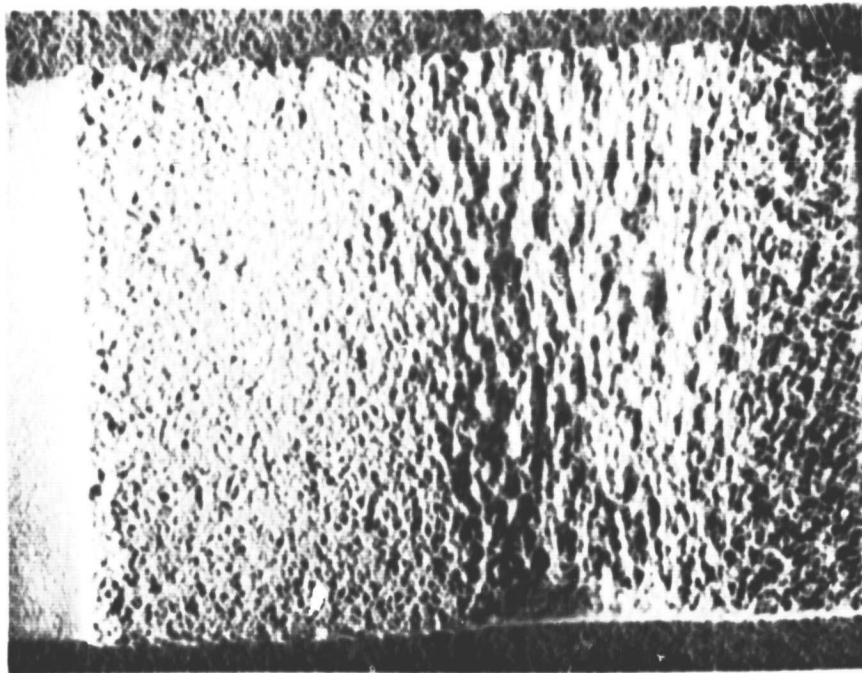
Figure 43c Erosion test results for System III 0 (50 min. exposure)

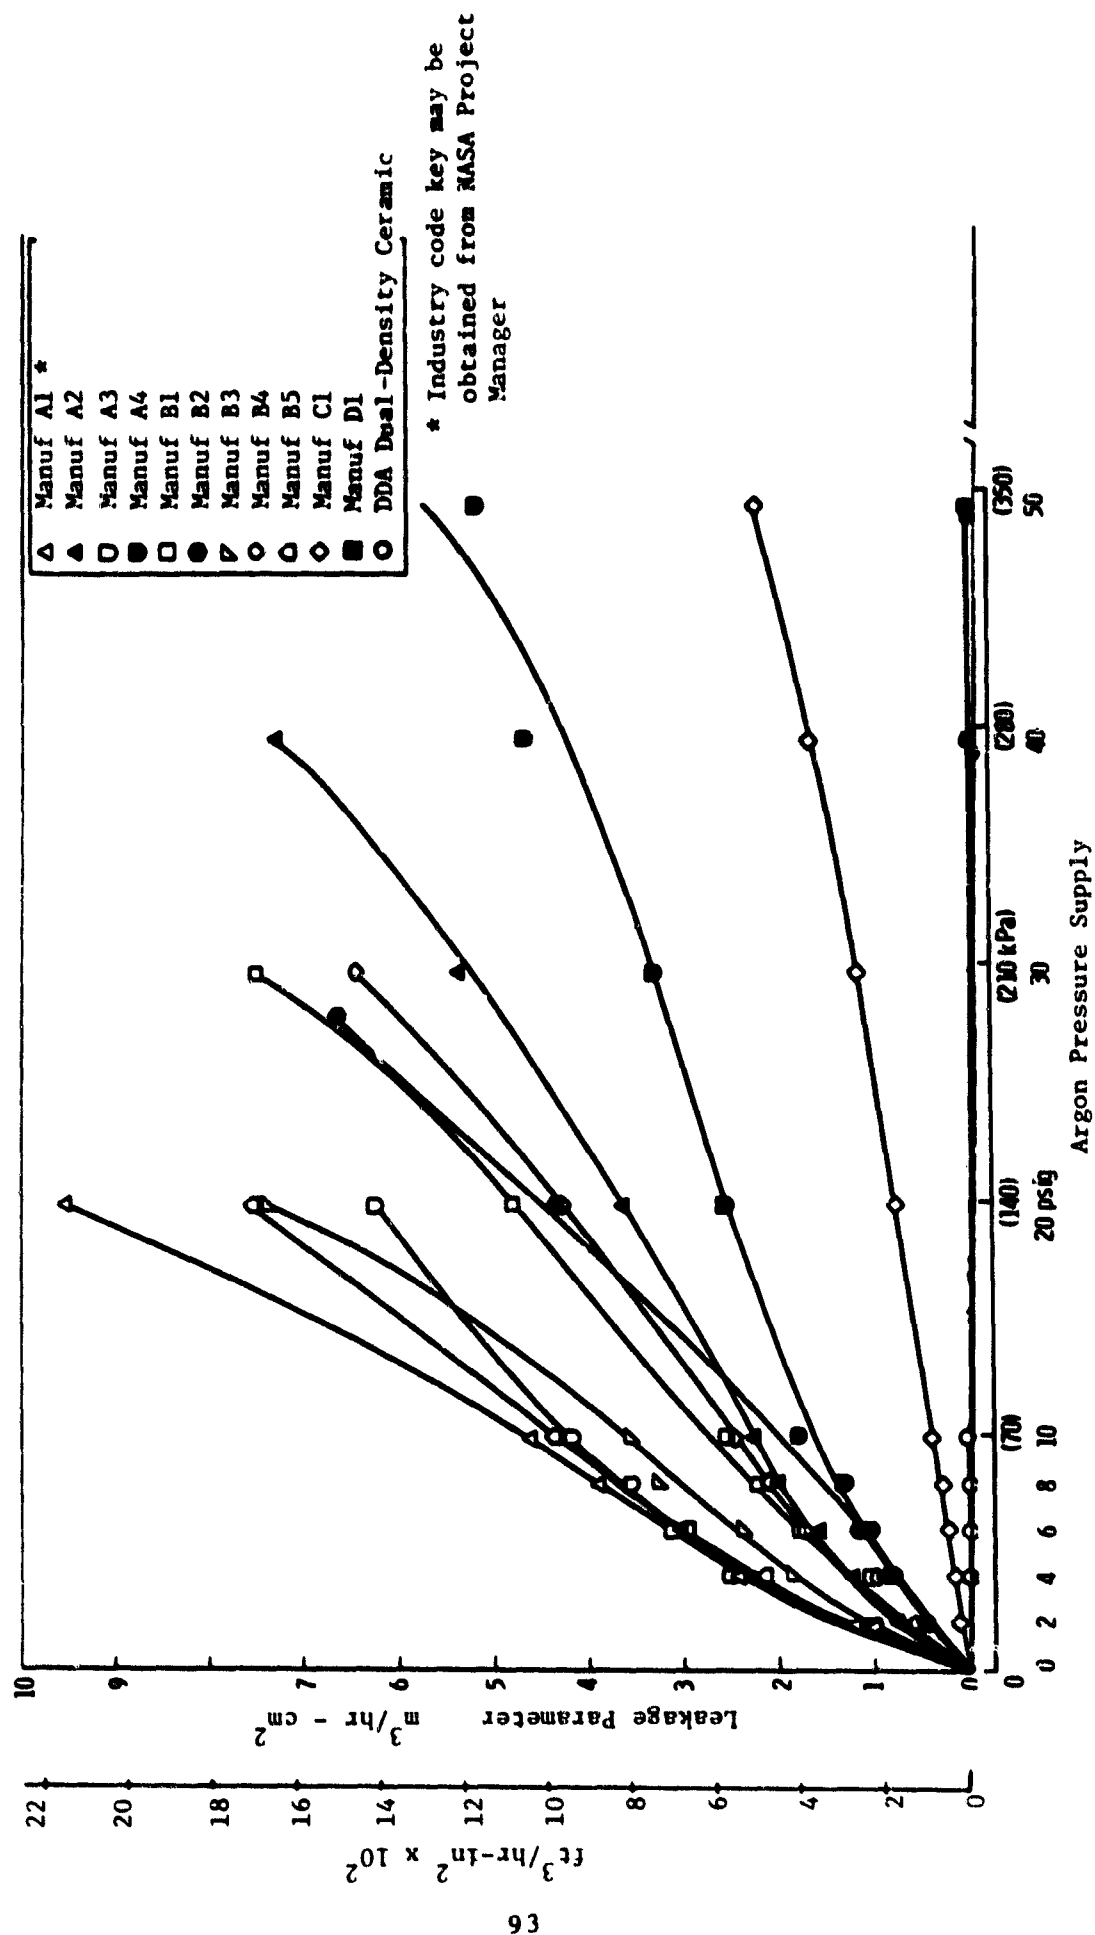
Figure 49 Abradable Seal Material Permeability

Gas flow permeability for each coating configuration in both the pre-stabilized and flame-stabilized matrix systems was measured using the procedure previously described. Static supply pressures up to 344.5 KPag (50 psig) were applied with zero leakage noted. These results are compared with the results obtained for conventional abradable materials in Figure 49.

The YSZ matrix systems exhibited nearly zero leakage compared to most of the conventional abradable materials. Many of the conventional materials rely on high levels of open porosity to provide abrasability, accounting for their high permeability.

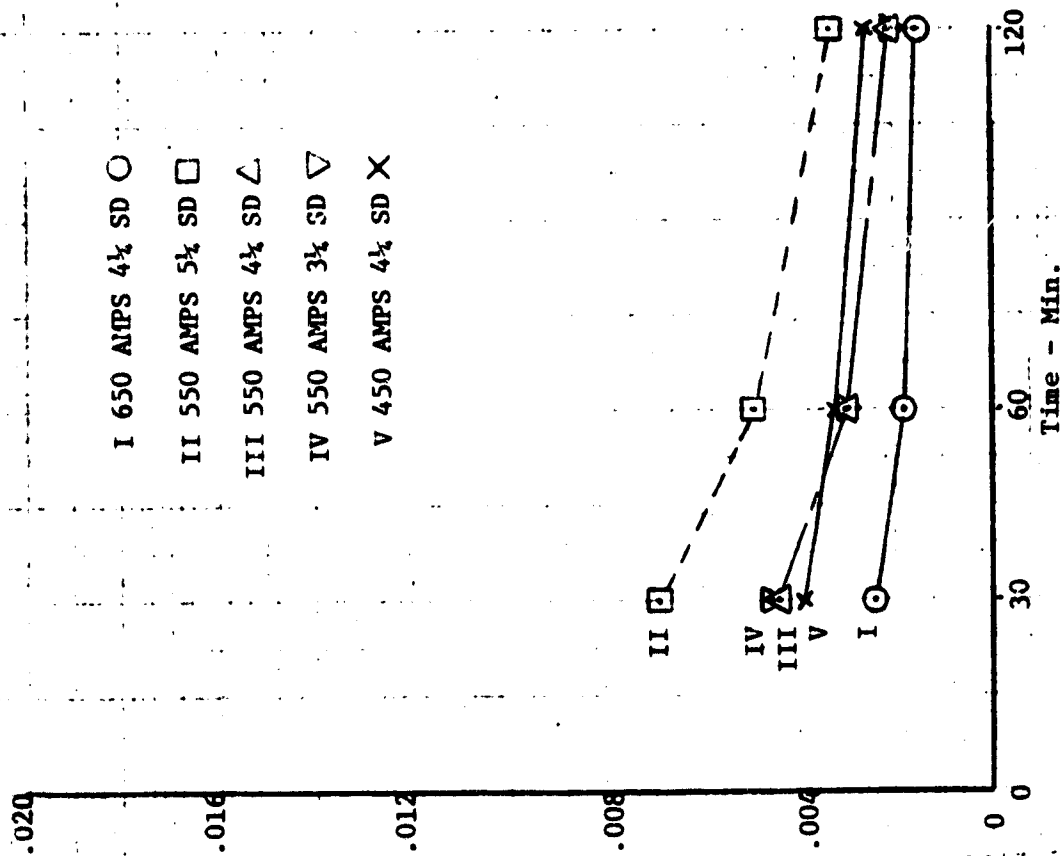
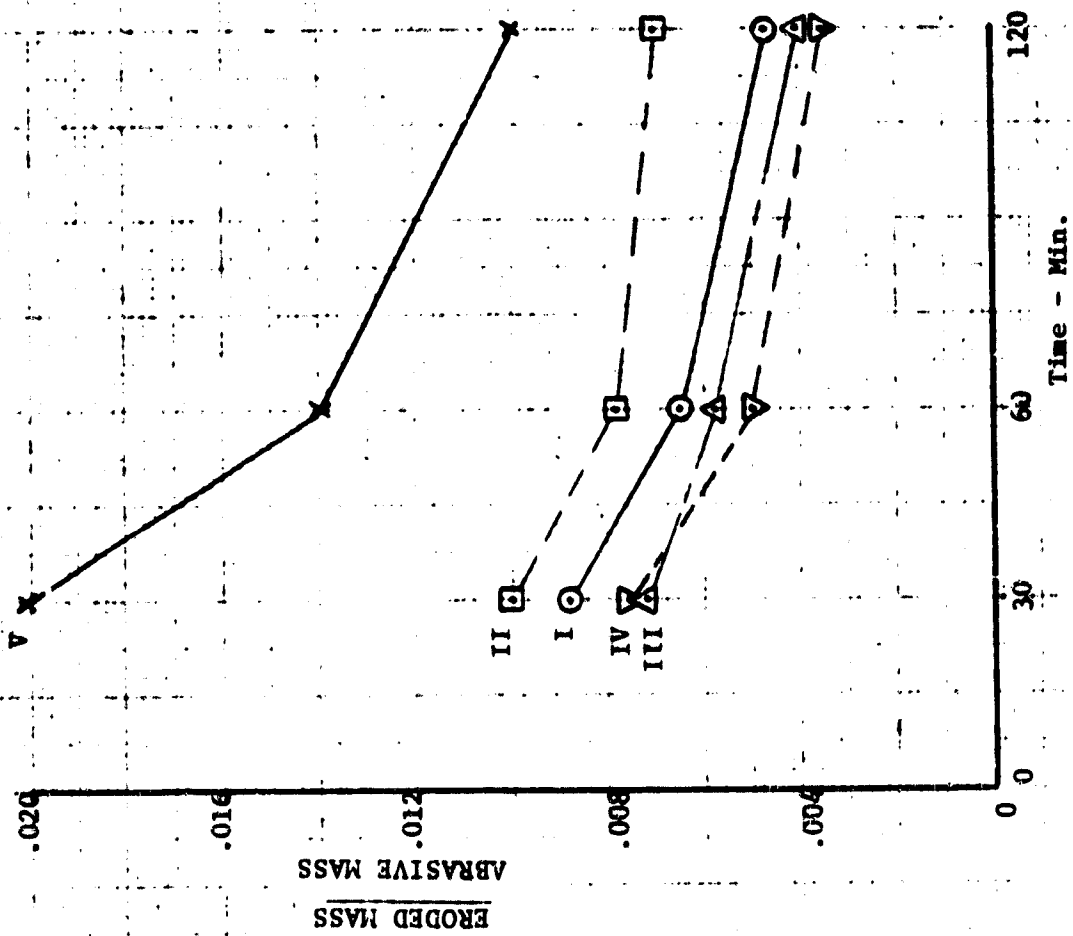
The 100% YSZ system, which is the standard NASA thermal barrier, is shown in Figure 50 for both the 8 w/o and the M-202 powders. The 8 w/o powder is clearly a more erosion resistant system than the M-202 powder. As the percentage of YSZ is decreased in favor of increasing percentages of eccospheres, the erosion resistance of the M-202 systems decrease more rapidly than the 8 w/o system, as is seen in Figures 52 through 54. In Figure 52, it is seen that the M-202 60/40 system has severely deteriorated in erosion resistance when compared to the 8 w/o system. Similar deteriorated performance is not experienced with the 8 w/o system until a 20/80 composition is tested. This is shown in Figure 55.

Figure 50 Erosion of 100% YSZ System

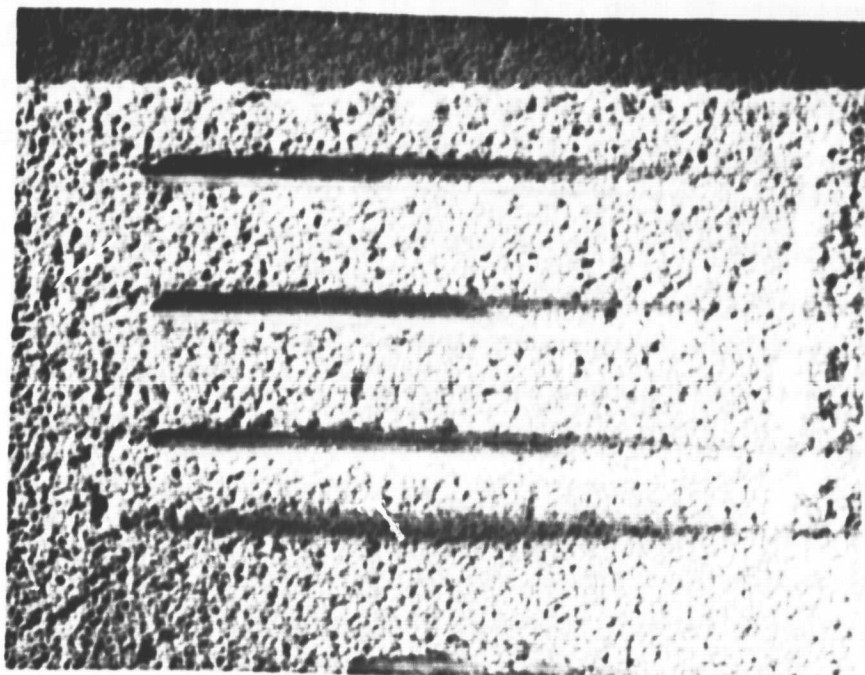
The composition selected for engine testing in the 4th stage turbine location of the GMA 500/ATDE was the 35/70 mixture corresponding to specimen "I". Two additional specimens were prepared with the hardness again ranging in the mid-50's on the R15Y scale. Low-speed room-temperature abrasability was checked to a depth of 0.016 in. with no distress to the labyrinth knives; erosion resistance was good, if not outstanding. The abrasability test wear scar is shown in Figure 57 in which some glazing of the seal material has occurred at the bottom of the grooves formed by the labyrinth knives.

Figure 57 Labyrinth seal abrasability test results IN 713 knives vs 35/70 M 202 YSZ/FA-A 0.016 in deep

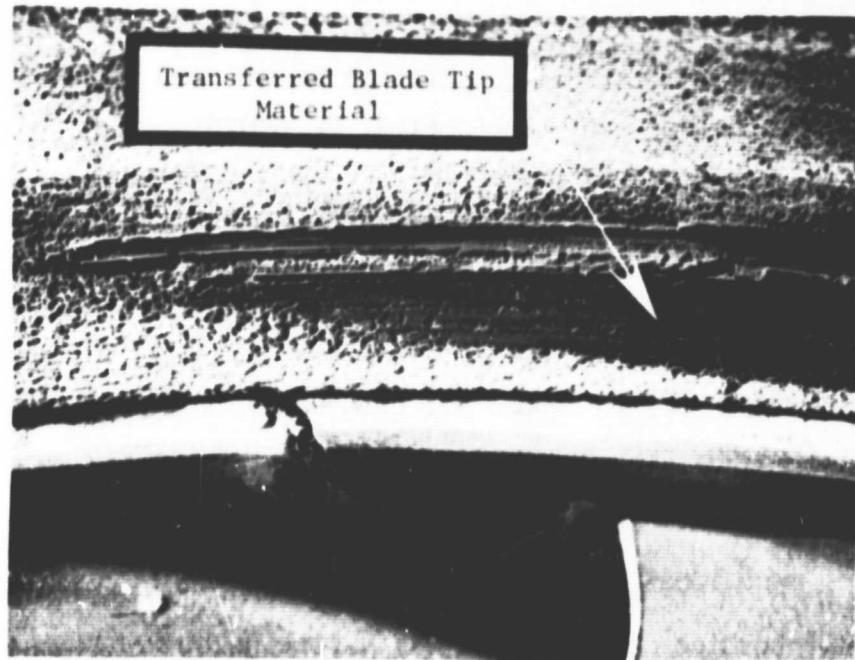
Adhesive transfer of blade tip material to the stationary seal surface resulted in the wear scar shown in Figure 65a. The corresponding distress to the blade tips is shown in Figure 65b, where the maximum depth of material removed was observed to be approximately .020 in. (.051 cm). Damage of this magnitude resulted in severe performance degradation requiring removal of the engine from the test stand.

a. Adhesive transfer of blade tip material to seal following rub
Magn: 3X

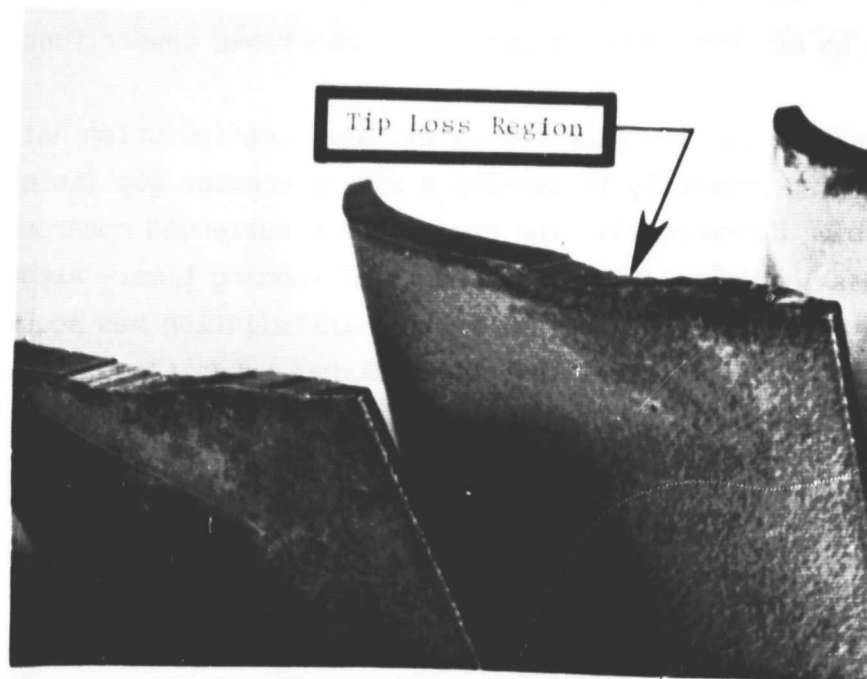
b. Resulting blade tip distress
Magn: 5X

Figure 65 CATE gasifier turbine tip seal rub results

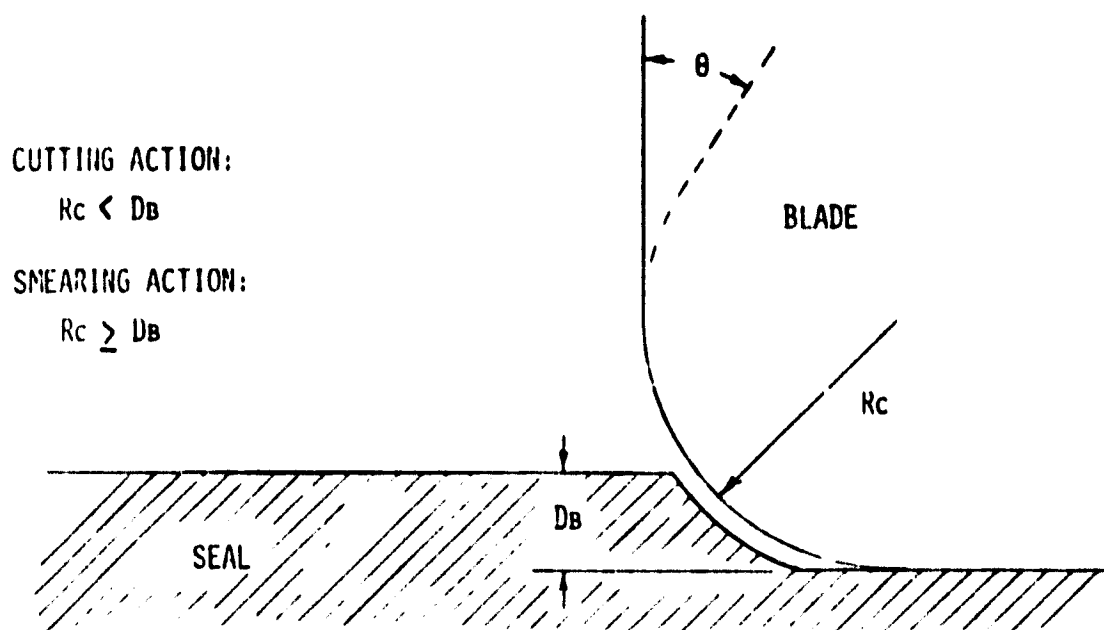
Figure 69 Material Removal Considerations

For a chip to be produced, the radius of curvature of the cutting "tool" (R_c , blade tip edge) must be less than the incursion (depth of cut) per blade. This is readily seen from Figure 69, in which the depth of cut is shown to be less than the tool cutting edge radius. It is obvious from this figure that the local tangent to the blade at or below the seal material surface will always indicate a resultant force (acting normal to the tangent) directed downward into the seal material with a forward component in the direction of engagement. Standard manufacturing techniques and materials are incapable of producing blades with edges sufficiently sharp to machine freely at the incursions encountered in actual rub situations. The end result is the smearing of the seal and adhesive transfer of the blade material to the seal structure frequently observed in practice.

Thus, for producible blades, movement of the blade into the seal will always tend to cause densification or compaction of the seal material. This explanation is compatible with the fact that no satisfactory turbine seal has yet been developed in spite of widespread industry attention.
